F-5-92

John N. Clay Farmstead

F-5-92
John N. Clay Farmstead
Kemptown
Frederick County

Maryland Historical Trust State Historic Sites Inventory Form

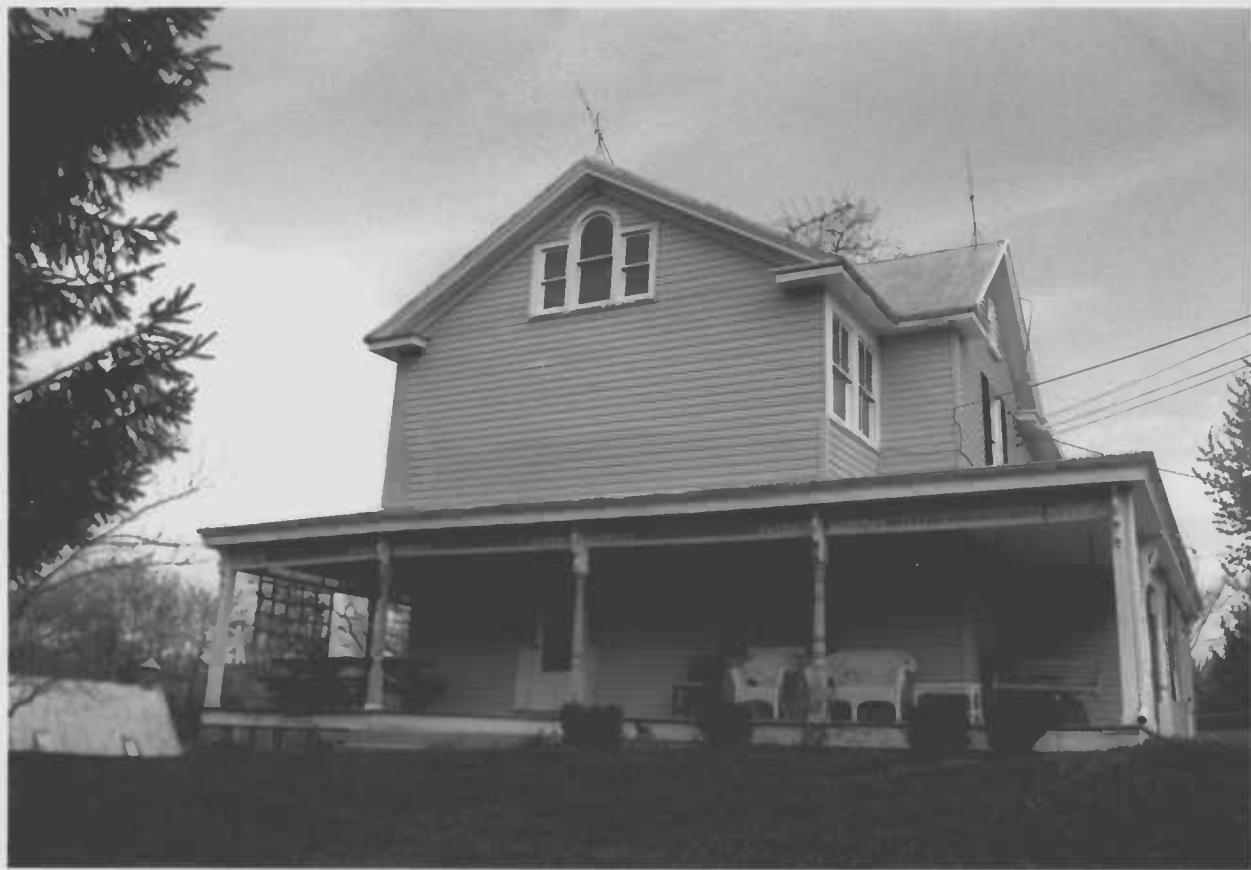
1/7

South elevation

The dwelling's south elevation in its original form was dominated by a projecting cross gable from the main gable roof ridge. The gable extended on the second story over a one-story open veranda which sheltered three sides of the house. The second story cross gable had several windows on each of its three sides with an arched Palladian window in the gable peak. The vinyl siding application in recent years covered the entire south side of the cross gable, leaving the Palladian window as the only opening on the south side. The east and west sides of the gable each have two 2/2 windows, indicating the original sash type of the covered openings. Below the gable, the one-story porch has turned columns with brackets and a spindle frieze. The first story has two bays with an entrance in the west bay under a narrow two-light transom and sidelights. The flanking window bay has a 2/2 sash with replacement shutters. The roof is standing seam metal with an off-center chimney. The gable ends have a single center bay with an arched attic window and 2/2 sash in the first and second stories. The rear elevation has a two-story shed addition which has been altered near the northwest corner with a raised gable roof. This projects beyond the end of the veranda above an exposed cellar entrance on the west side. The east end of the addition has a one-story enclosure at the end of the veranda which is the current rear entrance to the kitchen of the house. Across the north elevation of the addition are three bays, each with 2/2 windows and replacement shutters. A second interior chimney rises from the roof. The dates of the changes to the house are difficult to identify by the exterior because the vinyl siding covers the original siding, which was probably german siding. The interior was inaccessible for this survey, but personal interviews with the current owners, Mrs. Hilda McPherson and Mrs. Dorothy Arrington, and the resident tenant indicate that considerable remodeling has taken place.

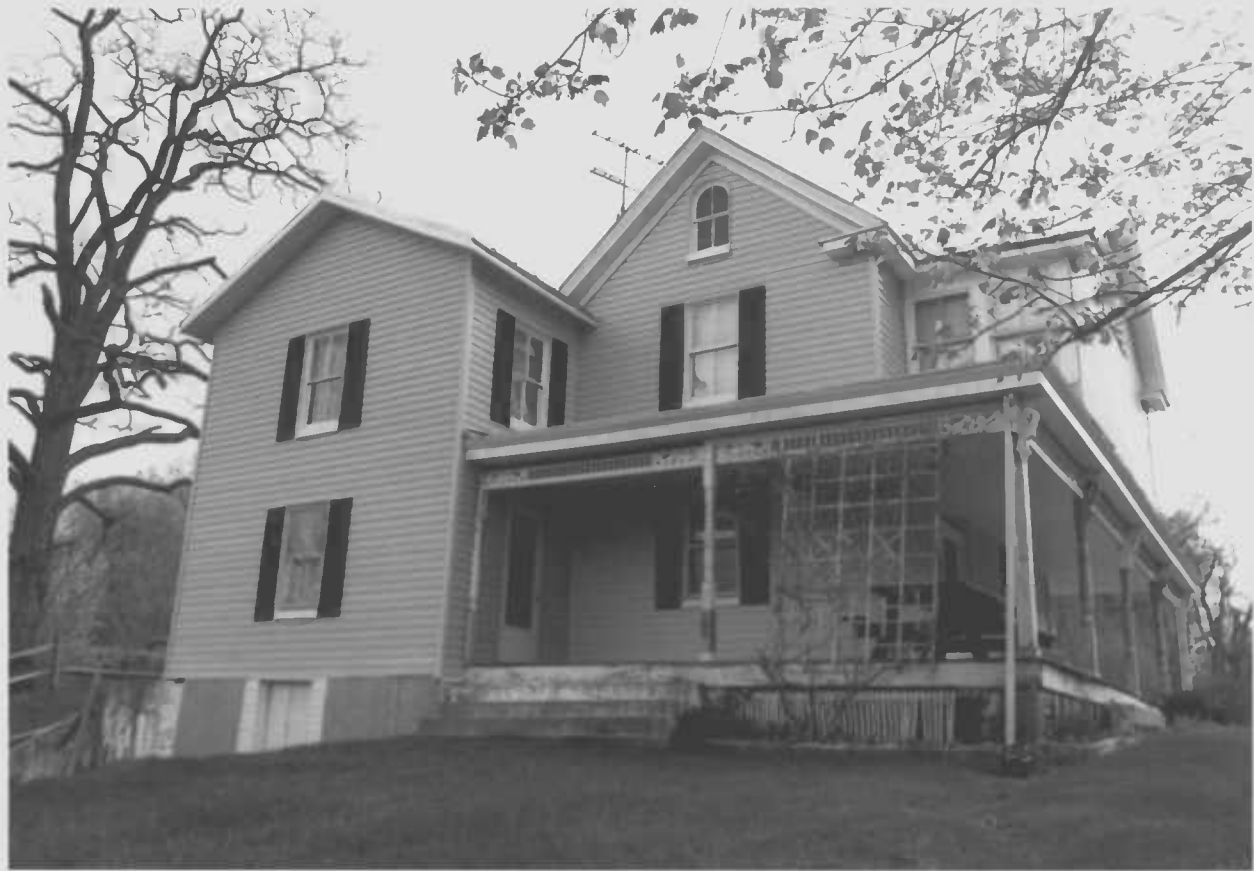
2/7

West elevation

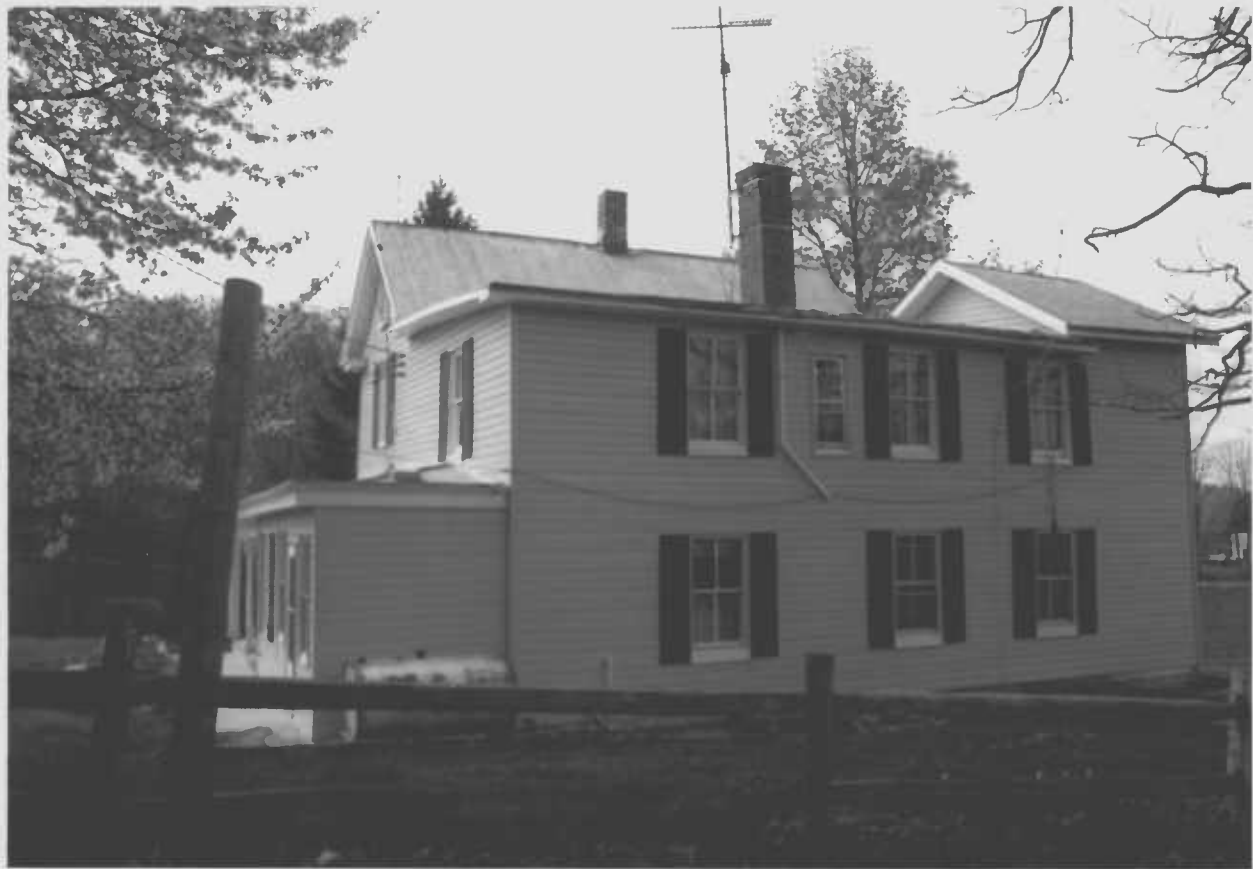
3/7

Net loc.: Mid. CHPO, Crownsville, Md.
North elevation

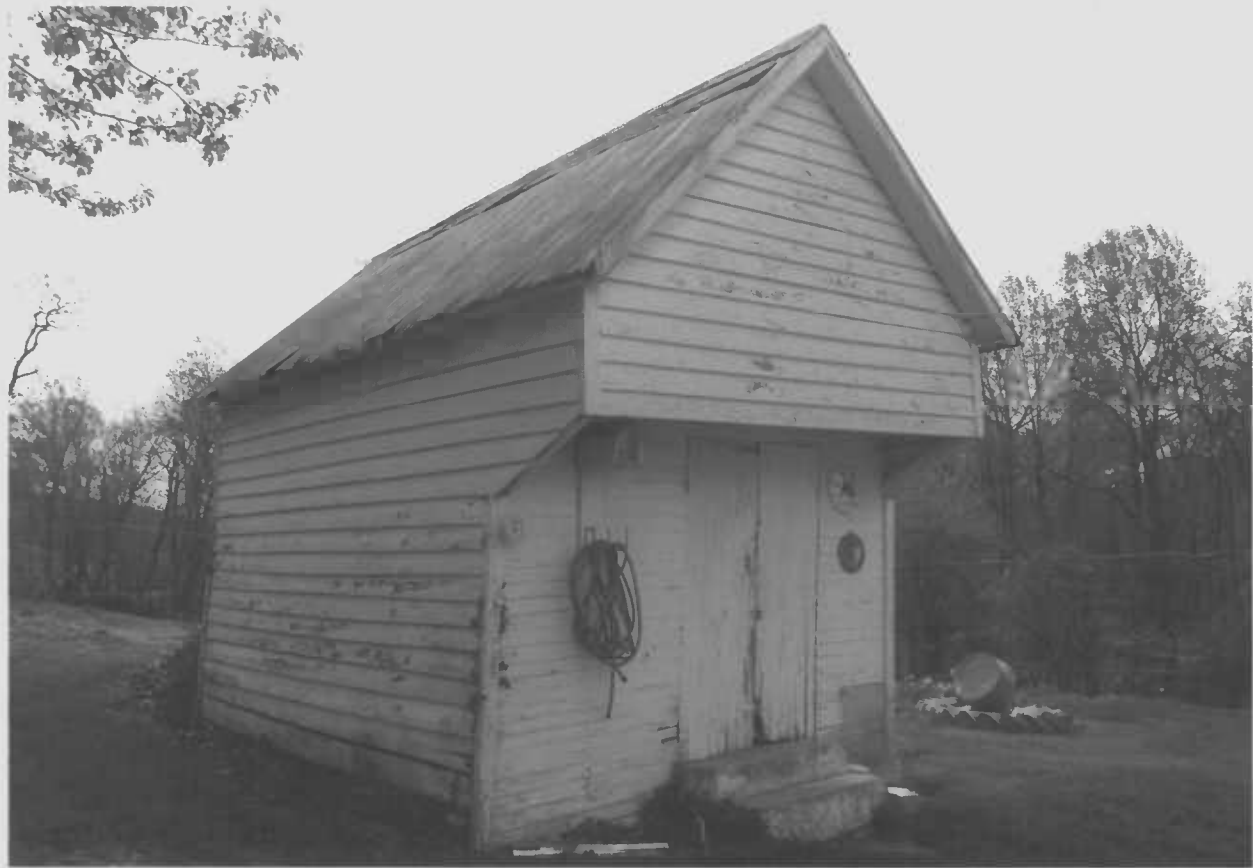
4/7

Meathouse: The frame meathouse located northeast of the house has clapboard siding and a corrugated metal roof. The roof extends over the west gable end, providing an enclosed loft cantilevered above the doorway, which is unusual in having double vertical tongue-and-groove doors. The meathouse was probably built about 1896.

Meathouse, northwest corner view

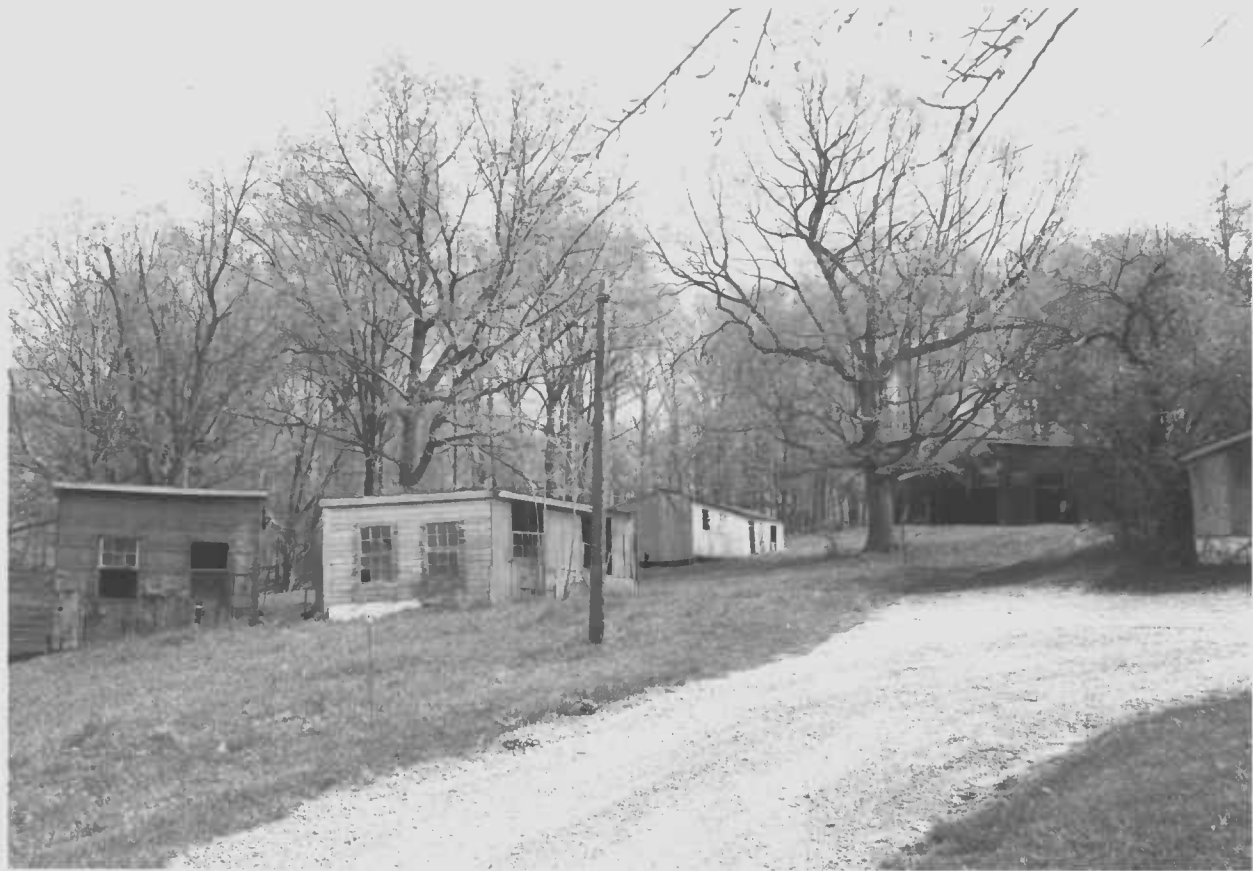
5/7

Chicken houses, hog barn, equipment shed: The agricultural outbuildings north and northeast of the dwelling are in deteriorated condition. At least three appear to be chicken houses and one was most probably built as a hog barn. Most have varied siding, some vertical boards, some clapboard, some covered with asphalt material. The shed roofs are corrugated metal. Windows are mostly 6/6 or openings with missing sash. The equipment shed has a higher roof with a shallow gable and two large openings on the west elevation. A frame shed northwest of the house near the north side of the driveway was also described as a chicken house by Mrs. McPherson. It has vertical siding which has traces of whitewash and a deteriorated corrugated metal roof with a single vertical board door on the south. These outbuildings range in date from about 1900 to 1930.

Neg. loc.: Md. SLPO Greensville Md
Chicken houses and equipment shed view from
west

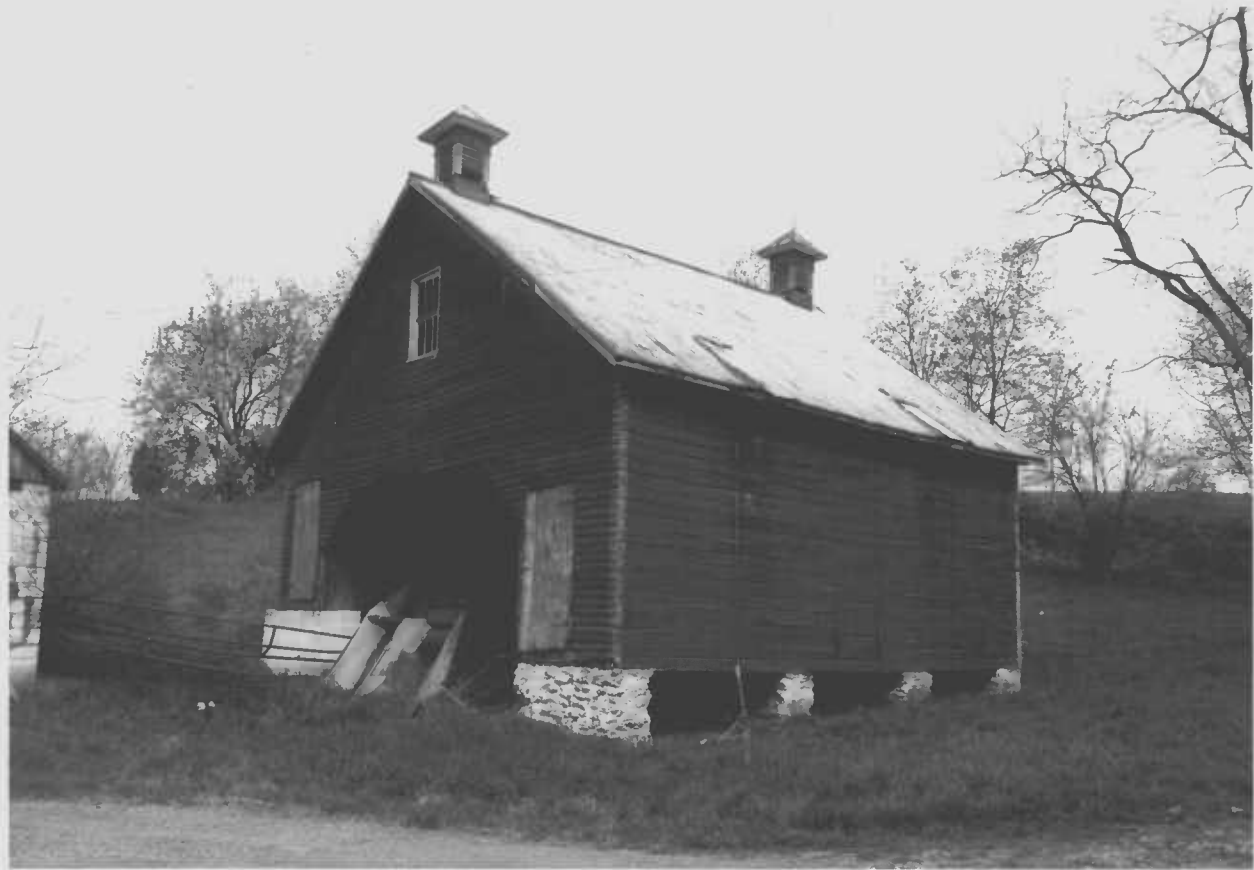
Wagon shed/corn crib: The frame wagon shed has german siding on the south elevation and vented horizontal siding on the east and west cribs. Stone piers raise the building from the ground and the corrugated metal roof is crowned by two louvred cupolas. A single 6/6 window lights the loft in the south elevation. The wagon shed was probably built about 1896-1900.

Wagon shed/corn crib, south-east corner view
6/7

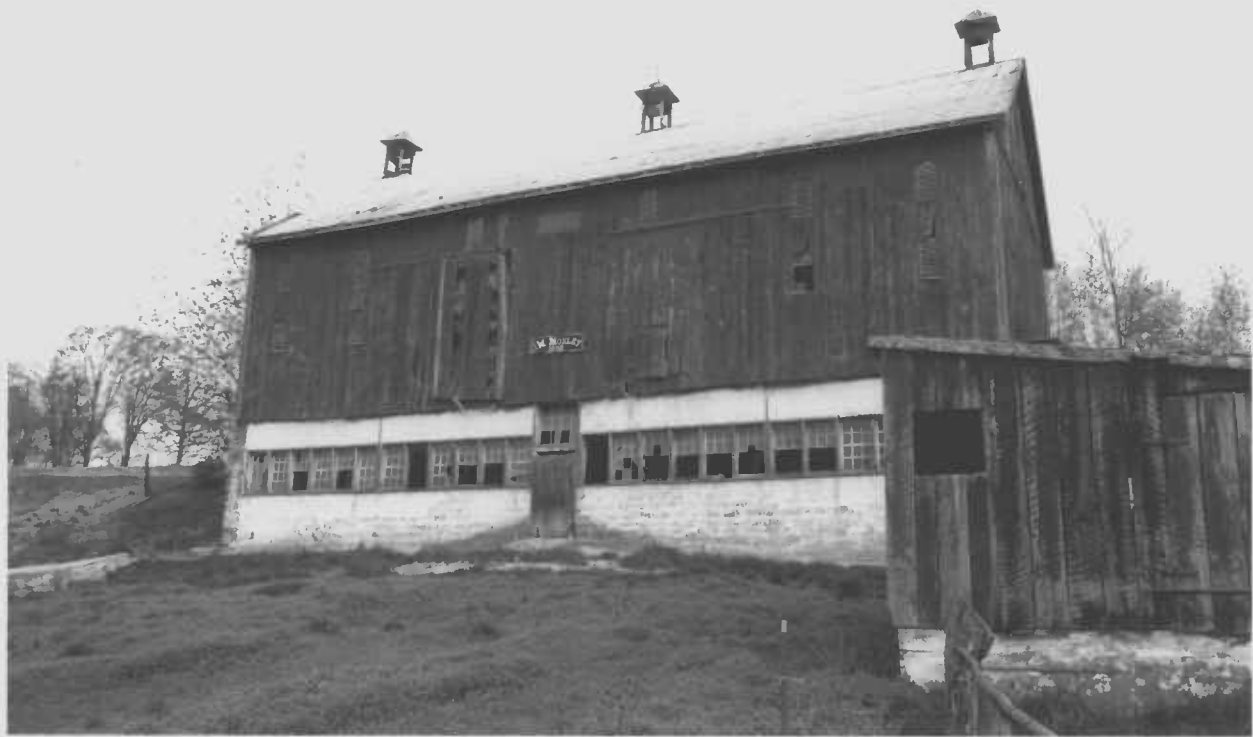
7/7

Bank barn and milk house: The frame and stone bank barn located west of the house was built about 1896-1900 and has three deteriorated cupolas on the ridge of the corrugated metal roof. The exterior has louvred arched vents and vertical siding. Below the forebay on the south elevation is an enclosure of concrete block with a bank of 6/6 windows, some of which are currently missing, which was added about 1920-1925 to form a milking parlor. Adjoining the barn on the east side is a rusticated concrete block milk house, probably built about 1925-1930. South of the barn is a non-contributing loafing shed. The sign on the barn with the name of J. W. Moxley and the date 1902 were originally on a barn in another farm owned by James W. Moxley. That barn was destroyed by lightning and the sign was salvaged and placed on the barn in the Clay farmstead, which was of about the same date. This information was provided by Mrs. McPherson and Mrs. Arrington, the daughters of Mr. Moxley.

Born. south elevation
